Manhole Inspection Summary

Manhole # **S15CC_010MH**

Insp Date: **7/3/08 3:43 PM**

Location Address: **REAR 1143 ASHBURTON**

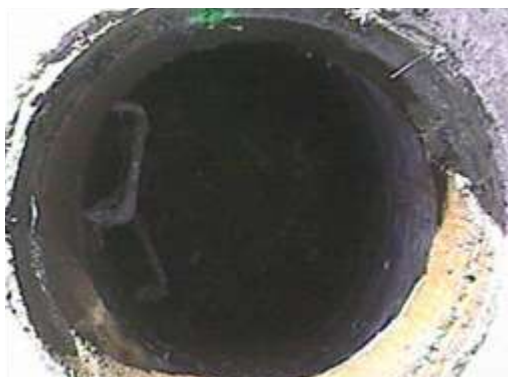
Defect 4

Condition: ☐ Sound ☒ **Cracked** ☐ Root Intrusion ☐ Loose Brick ☐ Deteriorated

CRACKED CHIMNEY

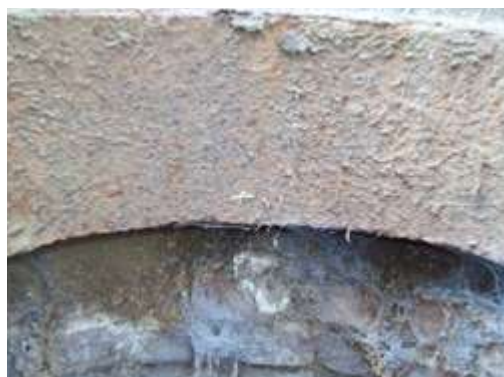
Defect 1

LOOSE BRICKS

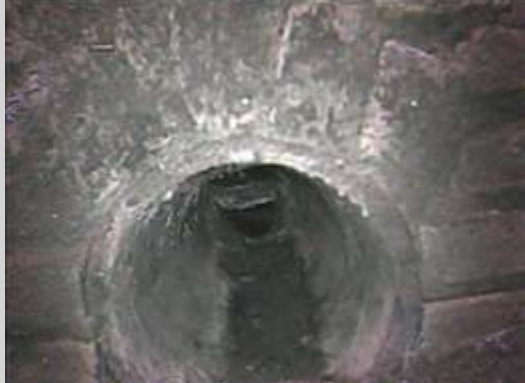
12 O'Clock Outflow

8 in. Circular Gravity Sewer
Pipe Out @ 12 O'Clock

Infiltration: **None** Pipe Seal Cond: **Sound**
